**How to set the jumpers correctly on interfaces
which use the NMEA channel**

This note applies to:

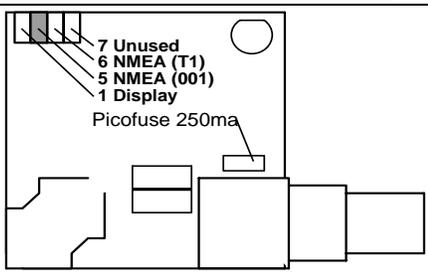
<p>042 NMEA tap (Rev A) Listen-only Default setting was channel 5 (for 001 systems)</p>

All NMEA taps 6

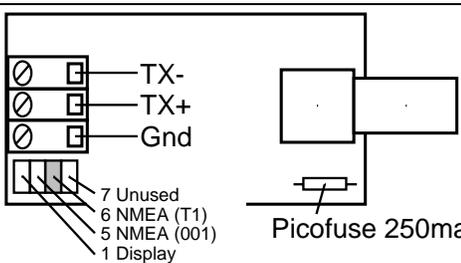
<p>042 NMEA tap (Rev B) Listen-only Default setting was channel 6 (for T1 systems)</p>
