OCKAM INSTRUMENTS, INC.

Troubleshooting Wind

This paper describes how to troubleshoot your wind sensor, mast cable and interface. Because the wind sensor is way up top of the mast, and the cable travels down the mast right next to halyards and must go thru the mast at two points, this instrument subsystem is one of the more vulnerable subsystems of the instrument package.

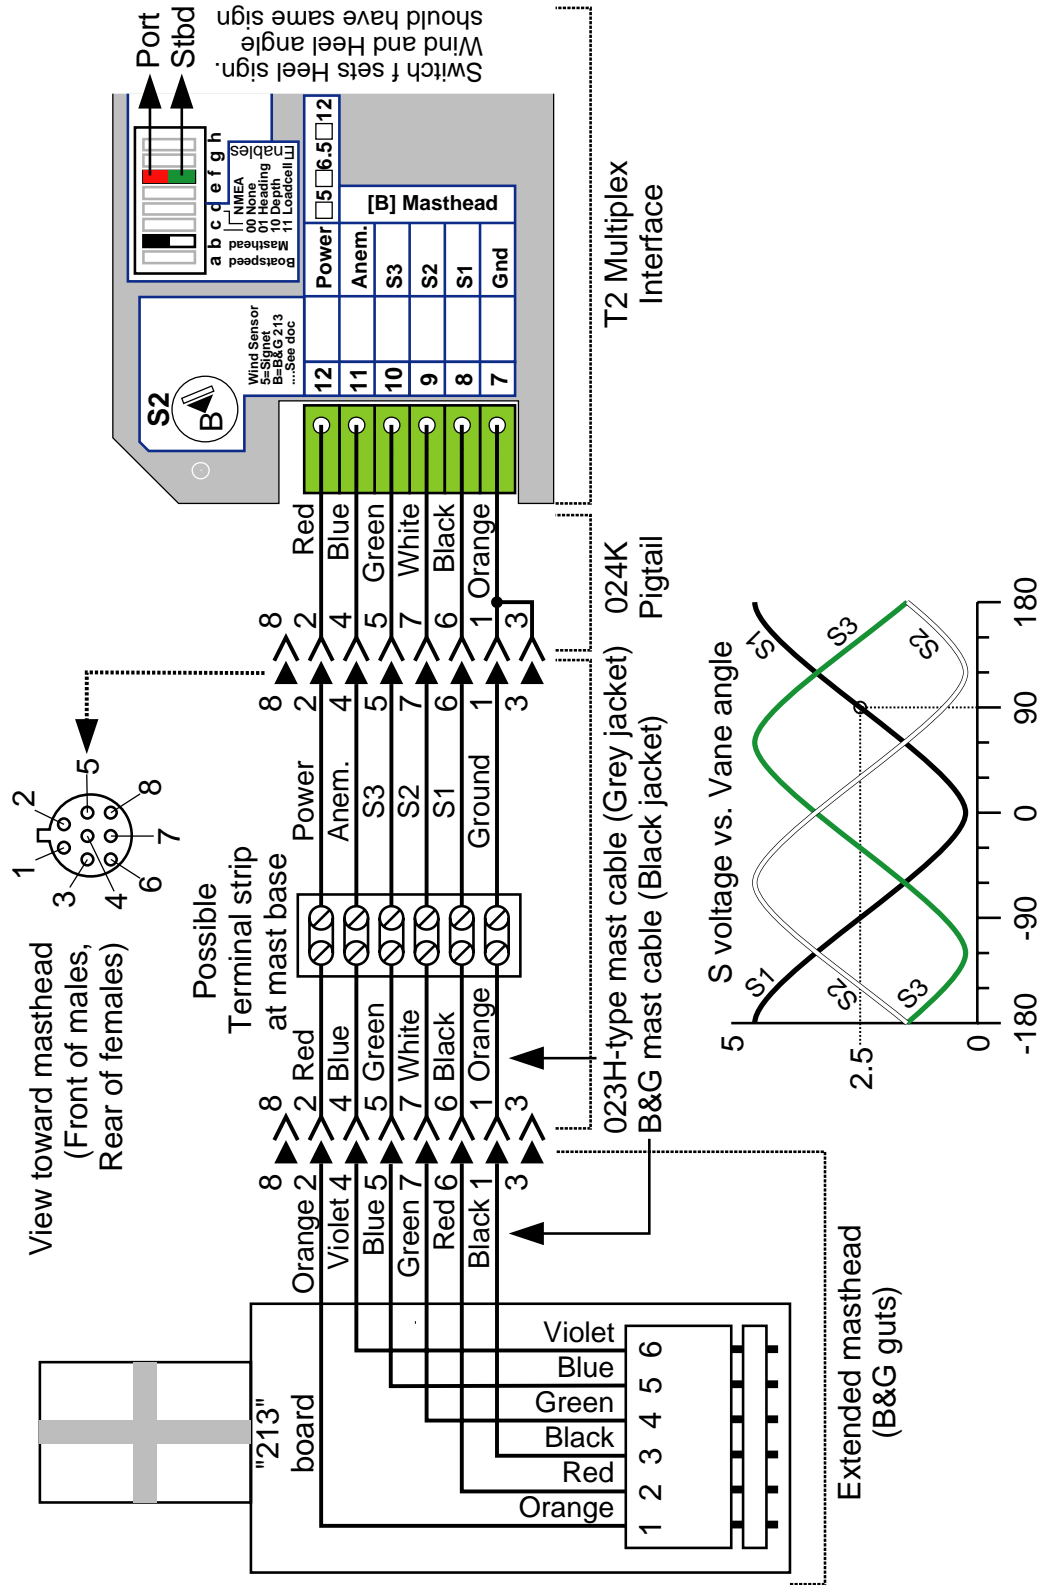
B &G-213 type mastheads

Connecting a B&G-type extended masthead to an Ockam System T2 Multiplex Interface
